**Report No. CG-D-08-00**

**EVALUATION OF WINDOW FAILURE MODES**

**FINAL REPORT  
DECEMBER 1999**

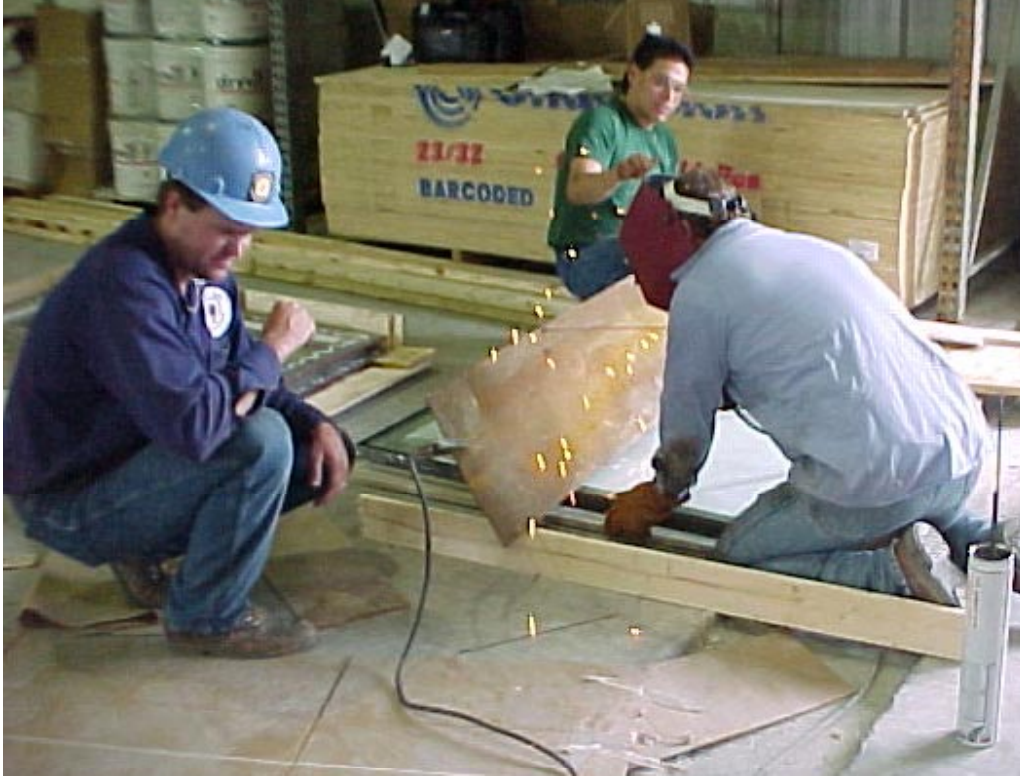
**Figure 5. Welding arrangement for damage.**

Prior to its installation in the bulkhead, one of the window assemblies was damaged using welding slag. This was accomplished with the window assembly in a horizontal position, and the arc welding (using a steel plate) above the top surface of the window assembly. This resulted in pitting of the tempered glass on the side to be exposed to the fire. figure 5 provides a photograph of the arrangement, and figure 6 provides a photograph of the damage. During the mounting of this window assembly, the damaged face of the window assembly completely fractured. figure 7 provides a photograph of the fractured glazing. It was deemed that this window assembly was not usable for further testing, and it was removed from the bulkhead.

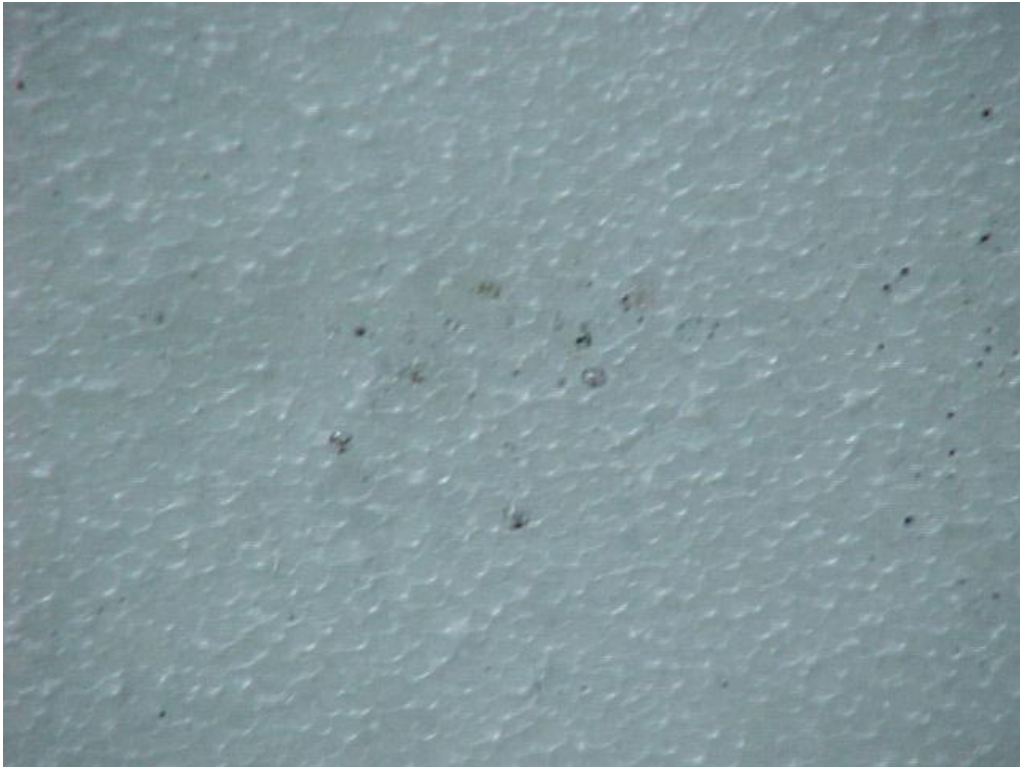
**Figure 6. Photograph of damage.**

Prior to actually damaging a window assembly, a separate piece of glazing was used for experimentation. Welding slag was produced via standard arc welding and a plasma cutter. It appeared that the arc welding would produce sufficient amounts of hot slag, which would impact the tempered glass, and due to their heat, cause pits to occur in the surface of the glass.

glazing and bounce off, which caused pits to form; however, these pits had a lesser depth than those formed on the horizontal glazing. These observations, along with the test results, would suggest that the depth of the damage to the glazing is an important factor in the failure of the glazing.

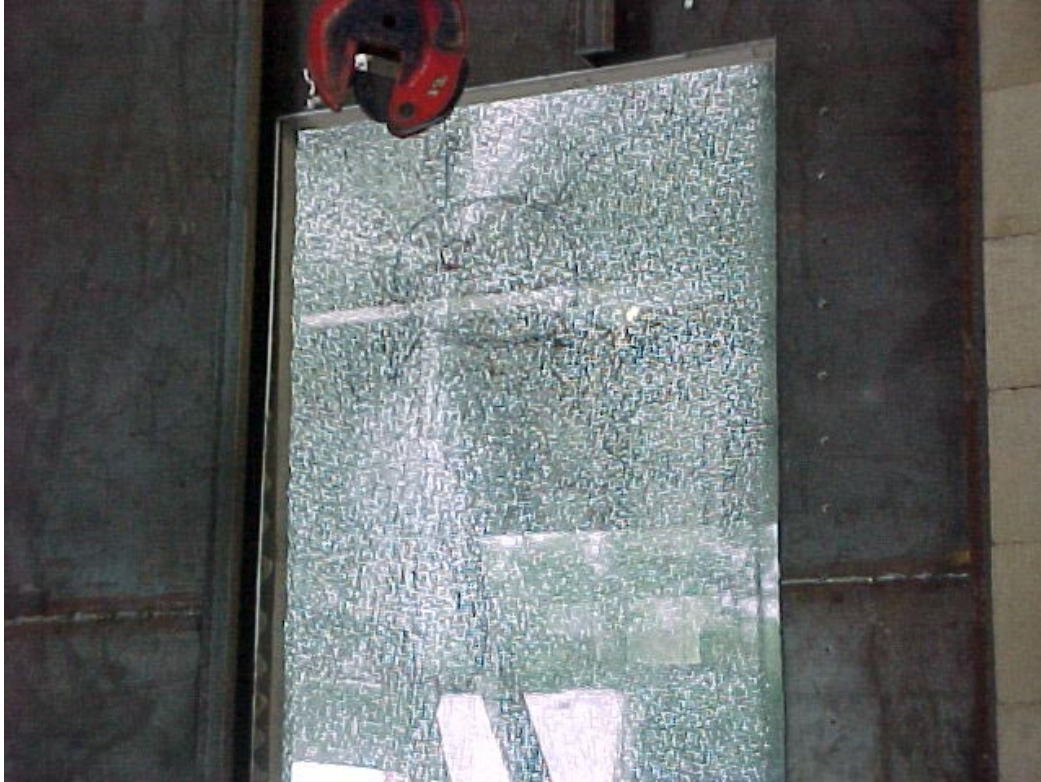
**Figure 7. Photograph of fractured glazing.**

Glass is a homogenous, isotropic material, and since glass fails suddenly without permanent deformation, it is considered a brittle material. In general, glass failure results from a tensile stress in combination with a defect or surface flaw (Gangnath, 1999). This behavior was noted in the failure of the horizontally damaged window.

The depth of the surface flaw (i.e., damage by the welding slag) could explain the premature failure of the horizontally damaged window. The horizontal orientation used to damage the window allowed the hot slag to remain on the surface of the glazing for a longer period of time than the slag used to damage the vertically orientated window. This longer time element allowed the slag to damage (pit) the horizontal glazing to a greater depth than in the case of the vertical window. When damaging the vertical window, the hot welding slag would hit the

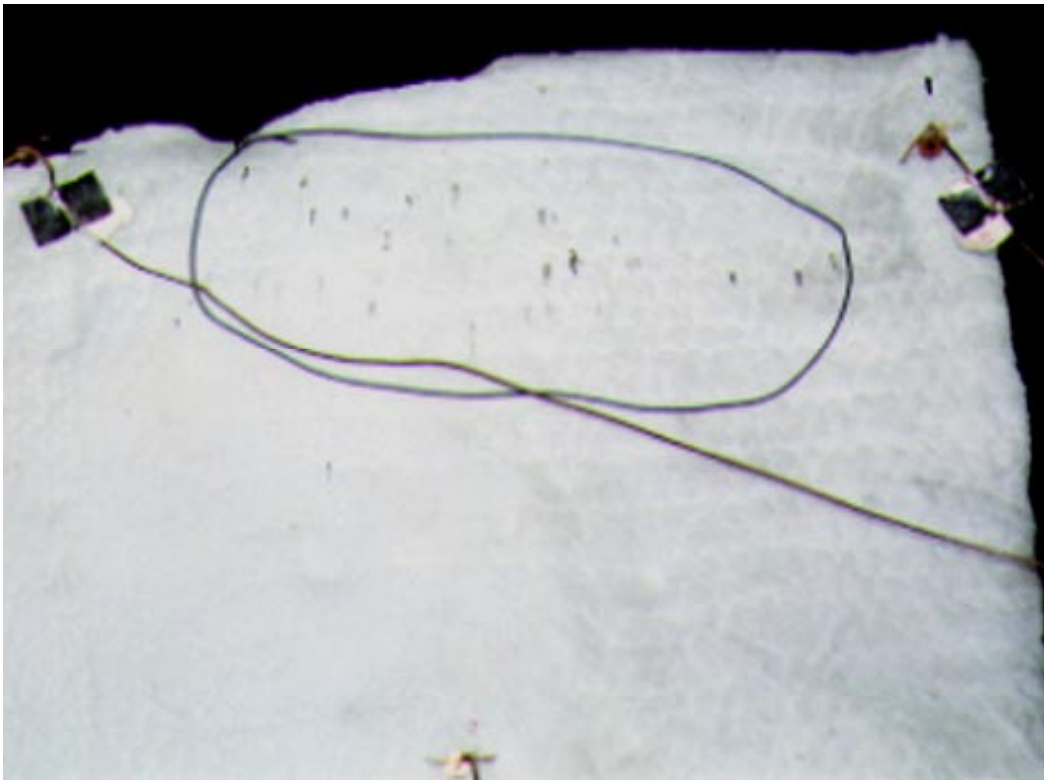
**Figure 8. Photograph of damage to the glazing.**

A second window assembly was selected for damage. In this case, the window was initially mounted into the test frame prior to damage. Once the window was properly installed in the bulkhead, the arc welding technique used to damage the first window assembly was again used, but the welding was performed in the vertical orientation. Again, damage to the glazing was accomplished (see figure 8), but it appeared that the damage to the glazing did not penetrate the glass to the depth that was noted in the first window assembly. In this instance, the window assembly was damaged on the side not directly exposed to the fire (unexposed side).

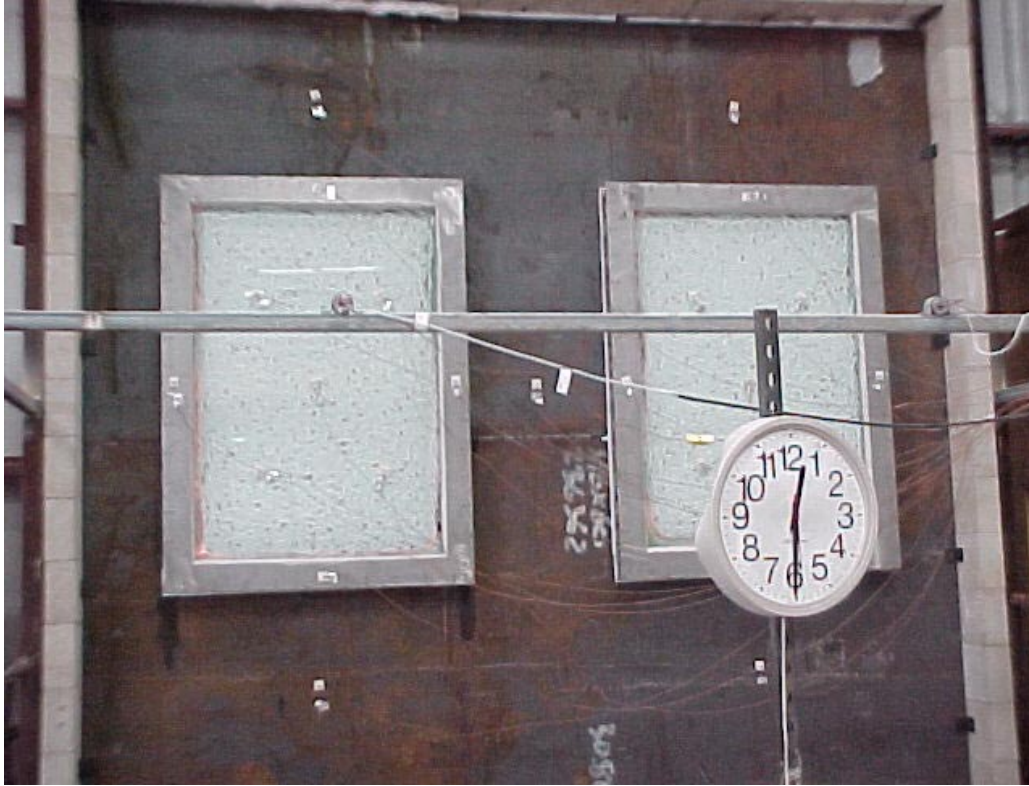
**Figure 12. Photograph of unexposed face at 30 minutes.**

During the test, the exposed layer of glass did fracture and fall from both of the assemblies. The gel did react to the heat, and it formed a char layer. The glass on the unexposed face of both window assemblies did not fracture or fall away.

Both the damaged and the undamaged window assemblies met the A-30 requirement of limiting the temperature rise for 30 minutes. The maximum measured heat fluxes were  $0.9 \text{ kW/m}^2$  on the damaged window and  $0.1 \text{ kW/m}^2$  on the undamaged window. These values were measured at the 35 minutes into the test period. In addition, on both the damaged and the undamaged windows, the unexposed side of the glazing, as well as the frame assembly, remained intact during the test.
